# Allied-Axis

THE PHOTO JOURNAL OF THE SECOND WORLD WAR

# Contents

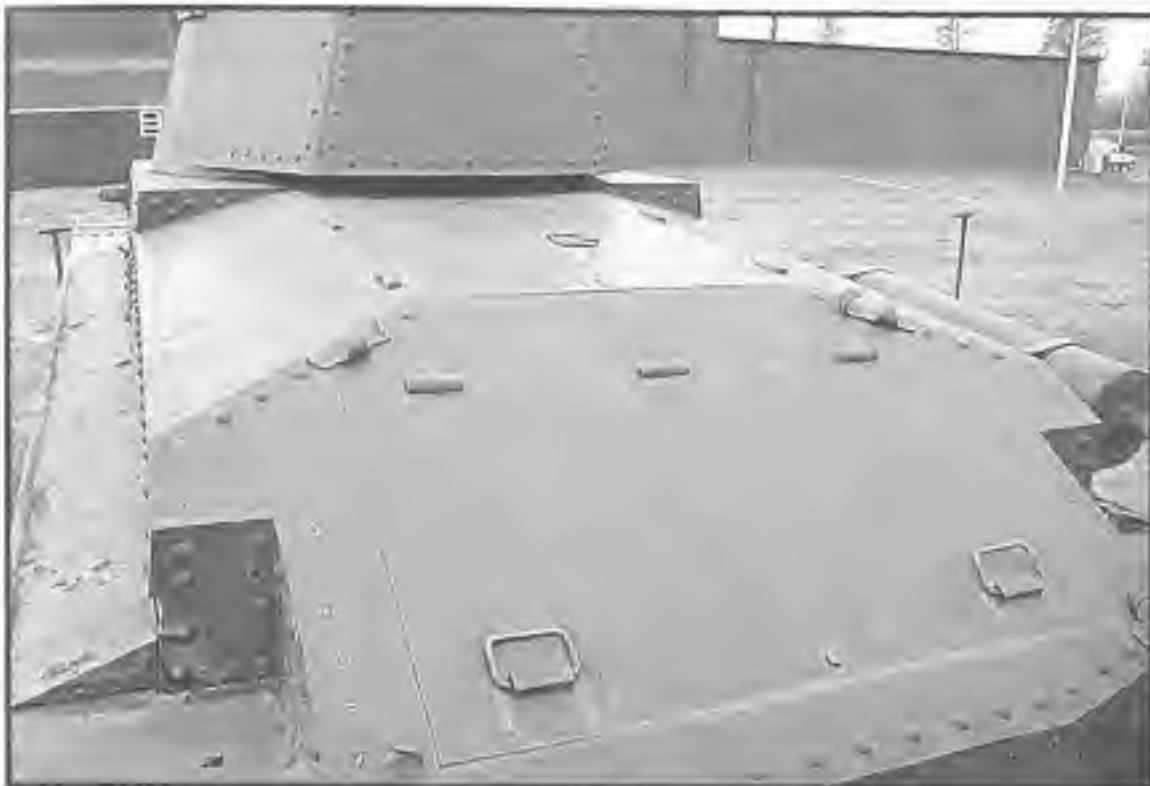
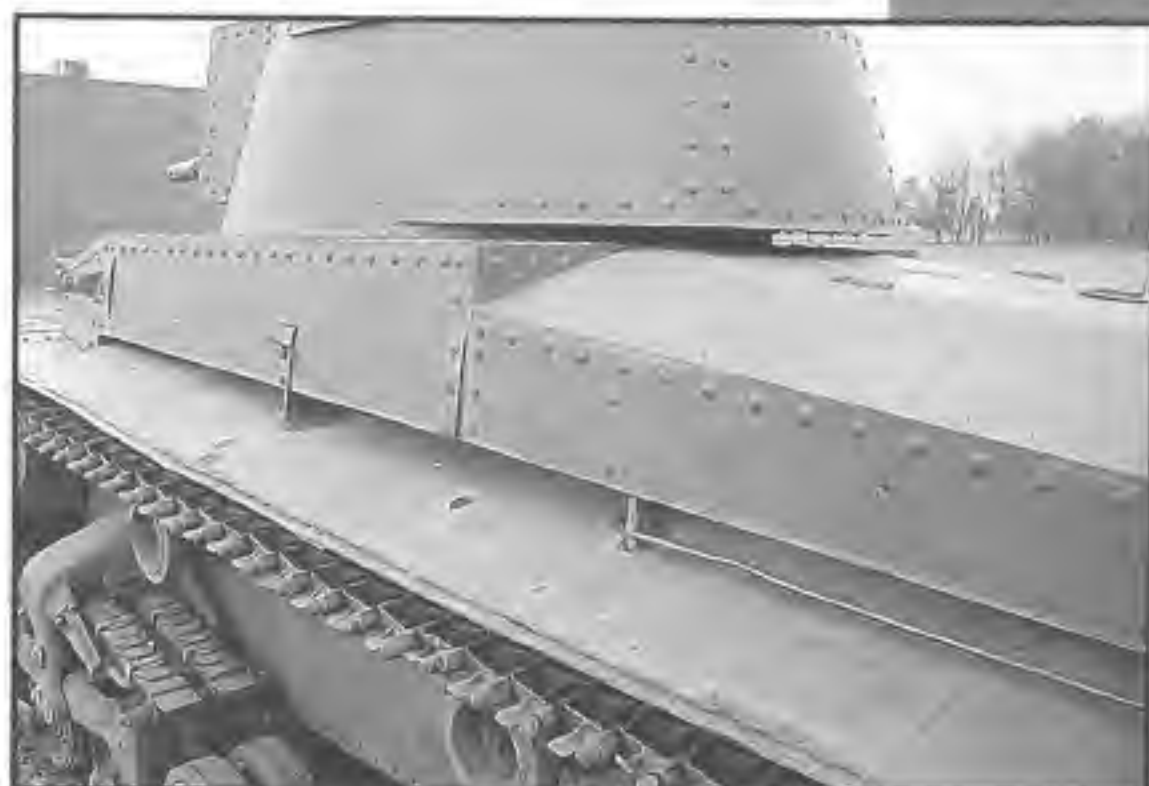
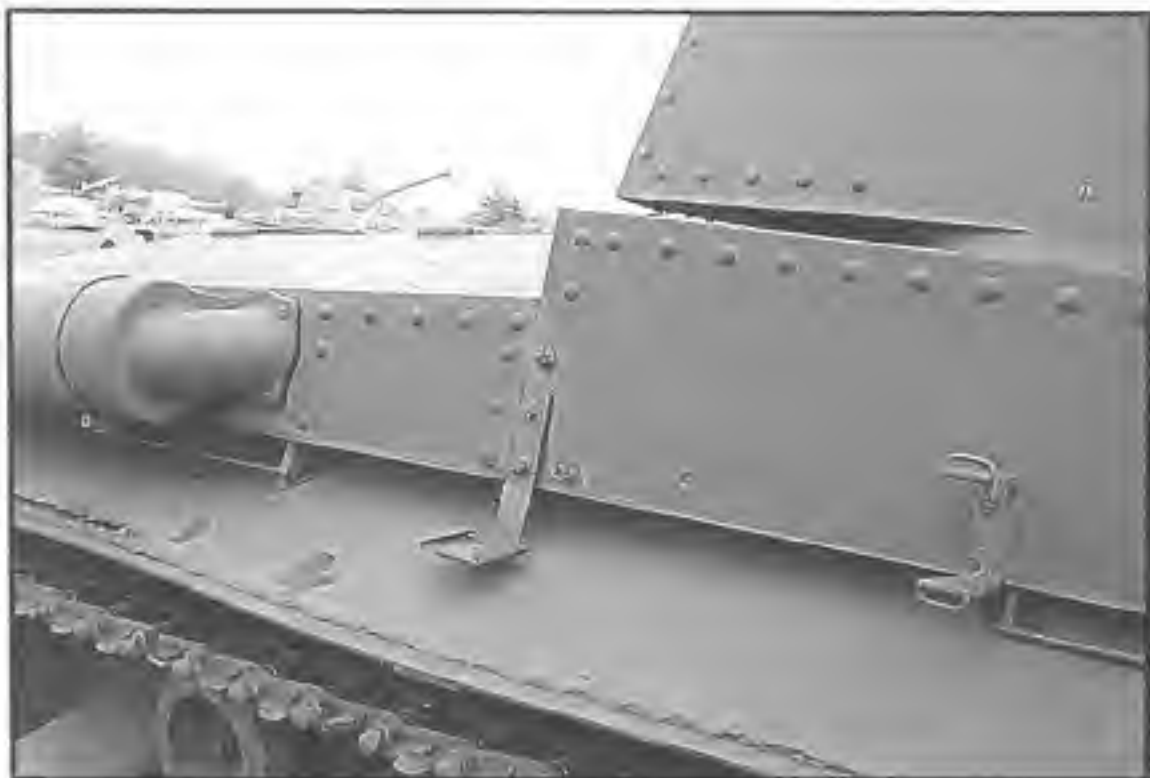
**Top left:** All of the armor on the 35(t) was designed to withstand rifle or machine gun rounds at distances over 75 meters. **Top right:** The vertical armor of the tank was 15mm thick, while the slanted armor plates were 12mm thick. **Above left:** At one time, these two brackets were part of the mount for

the jack. **Above right:** the large muffler on the right rear of the hull. Visible in this photo is one of a series of small rods welded along the fender line. It is thought these rods are to attach external stowage

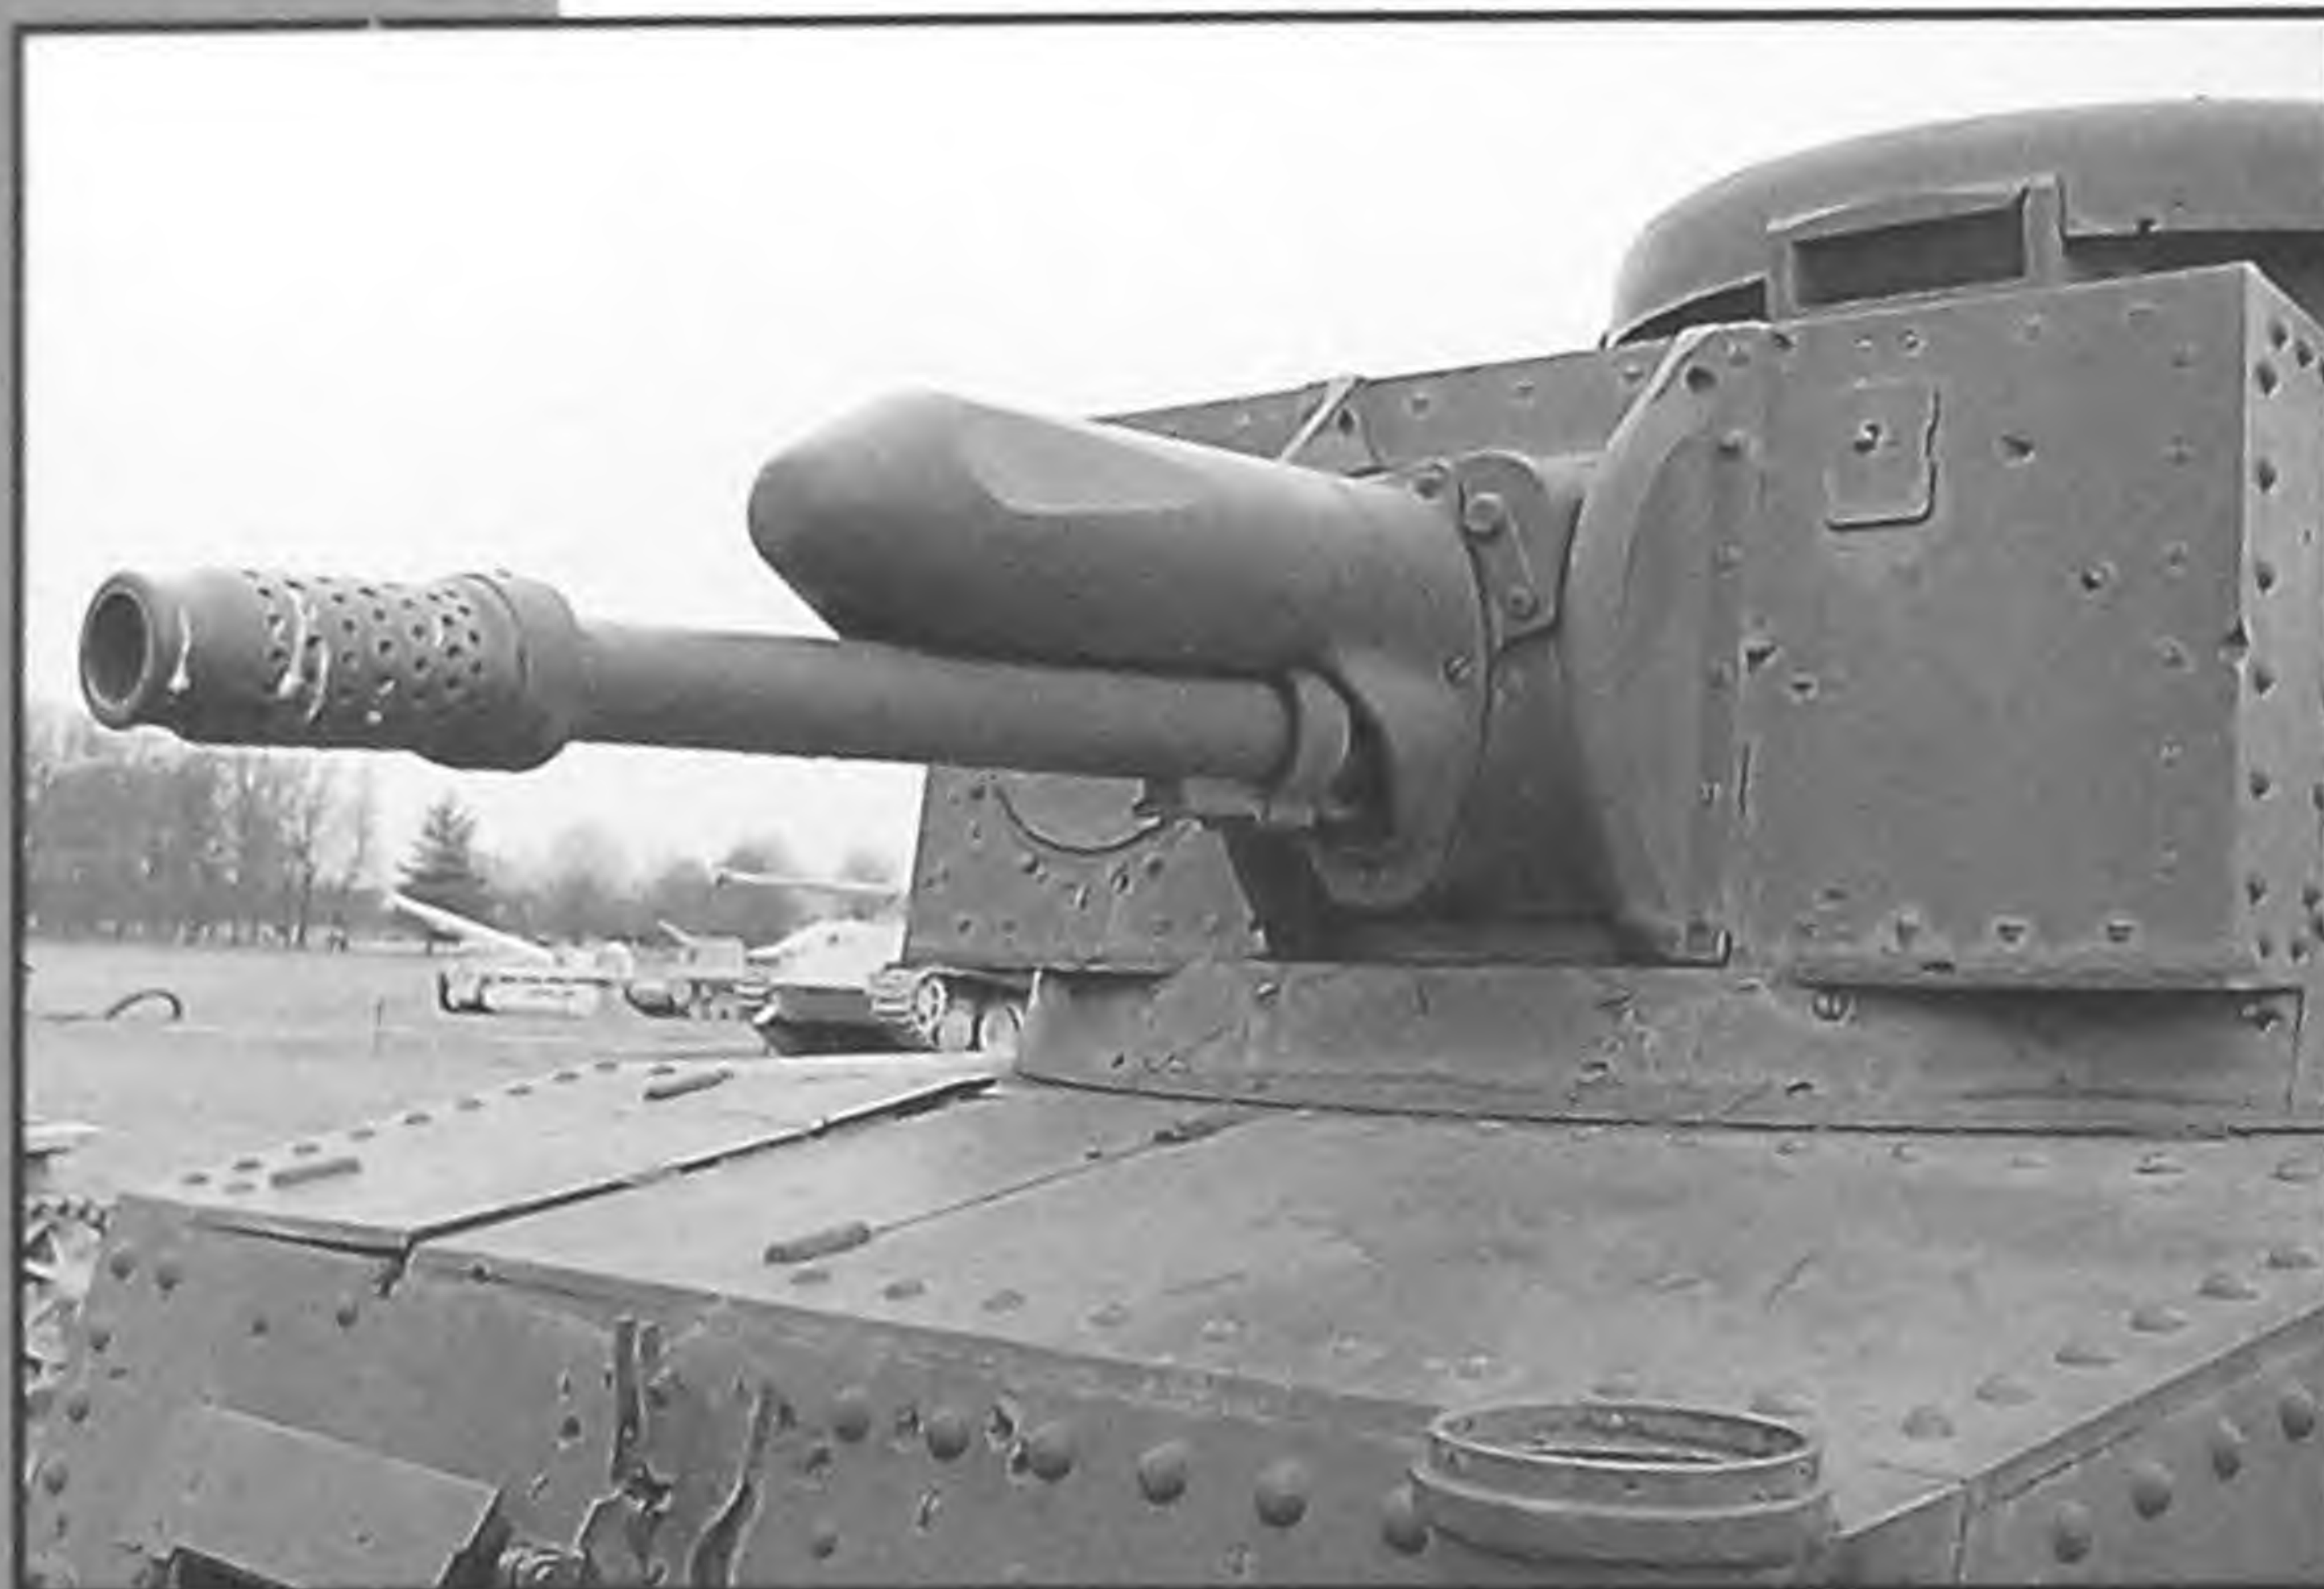
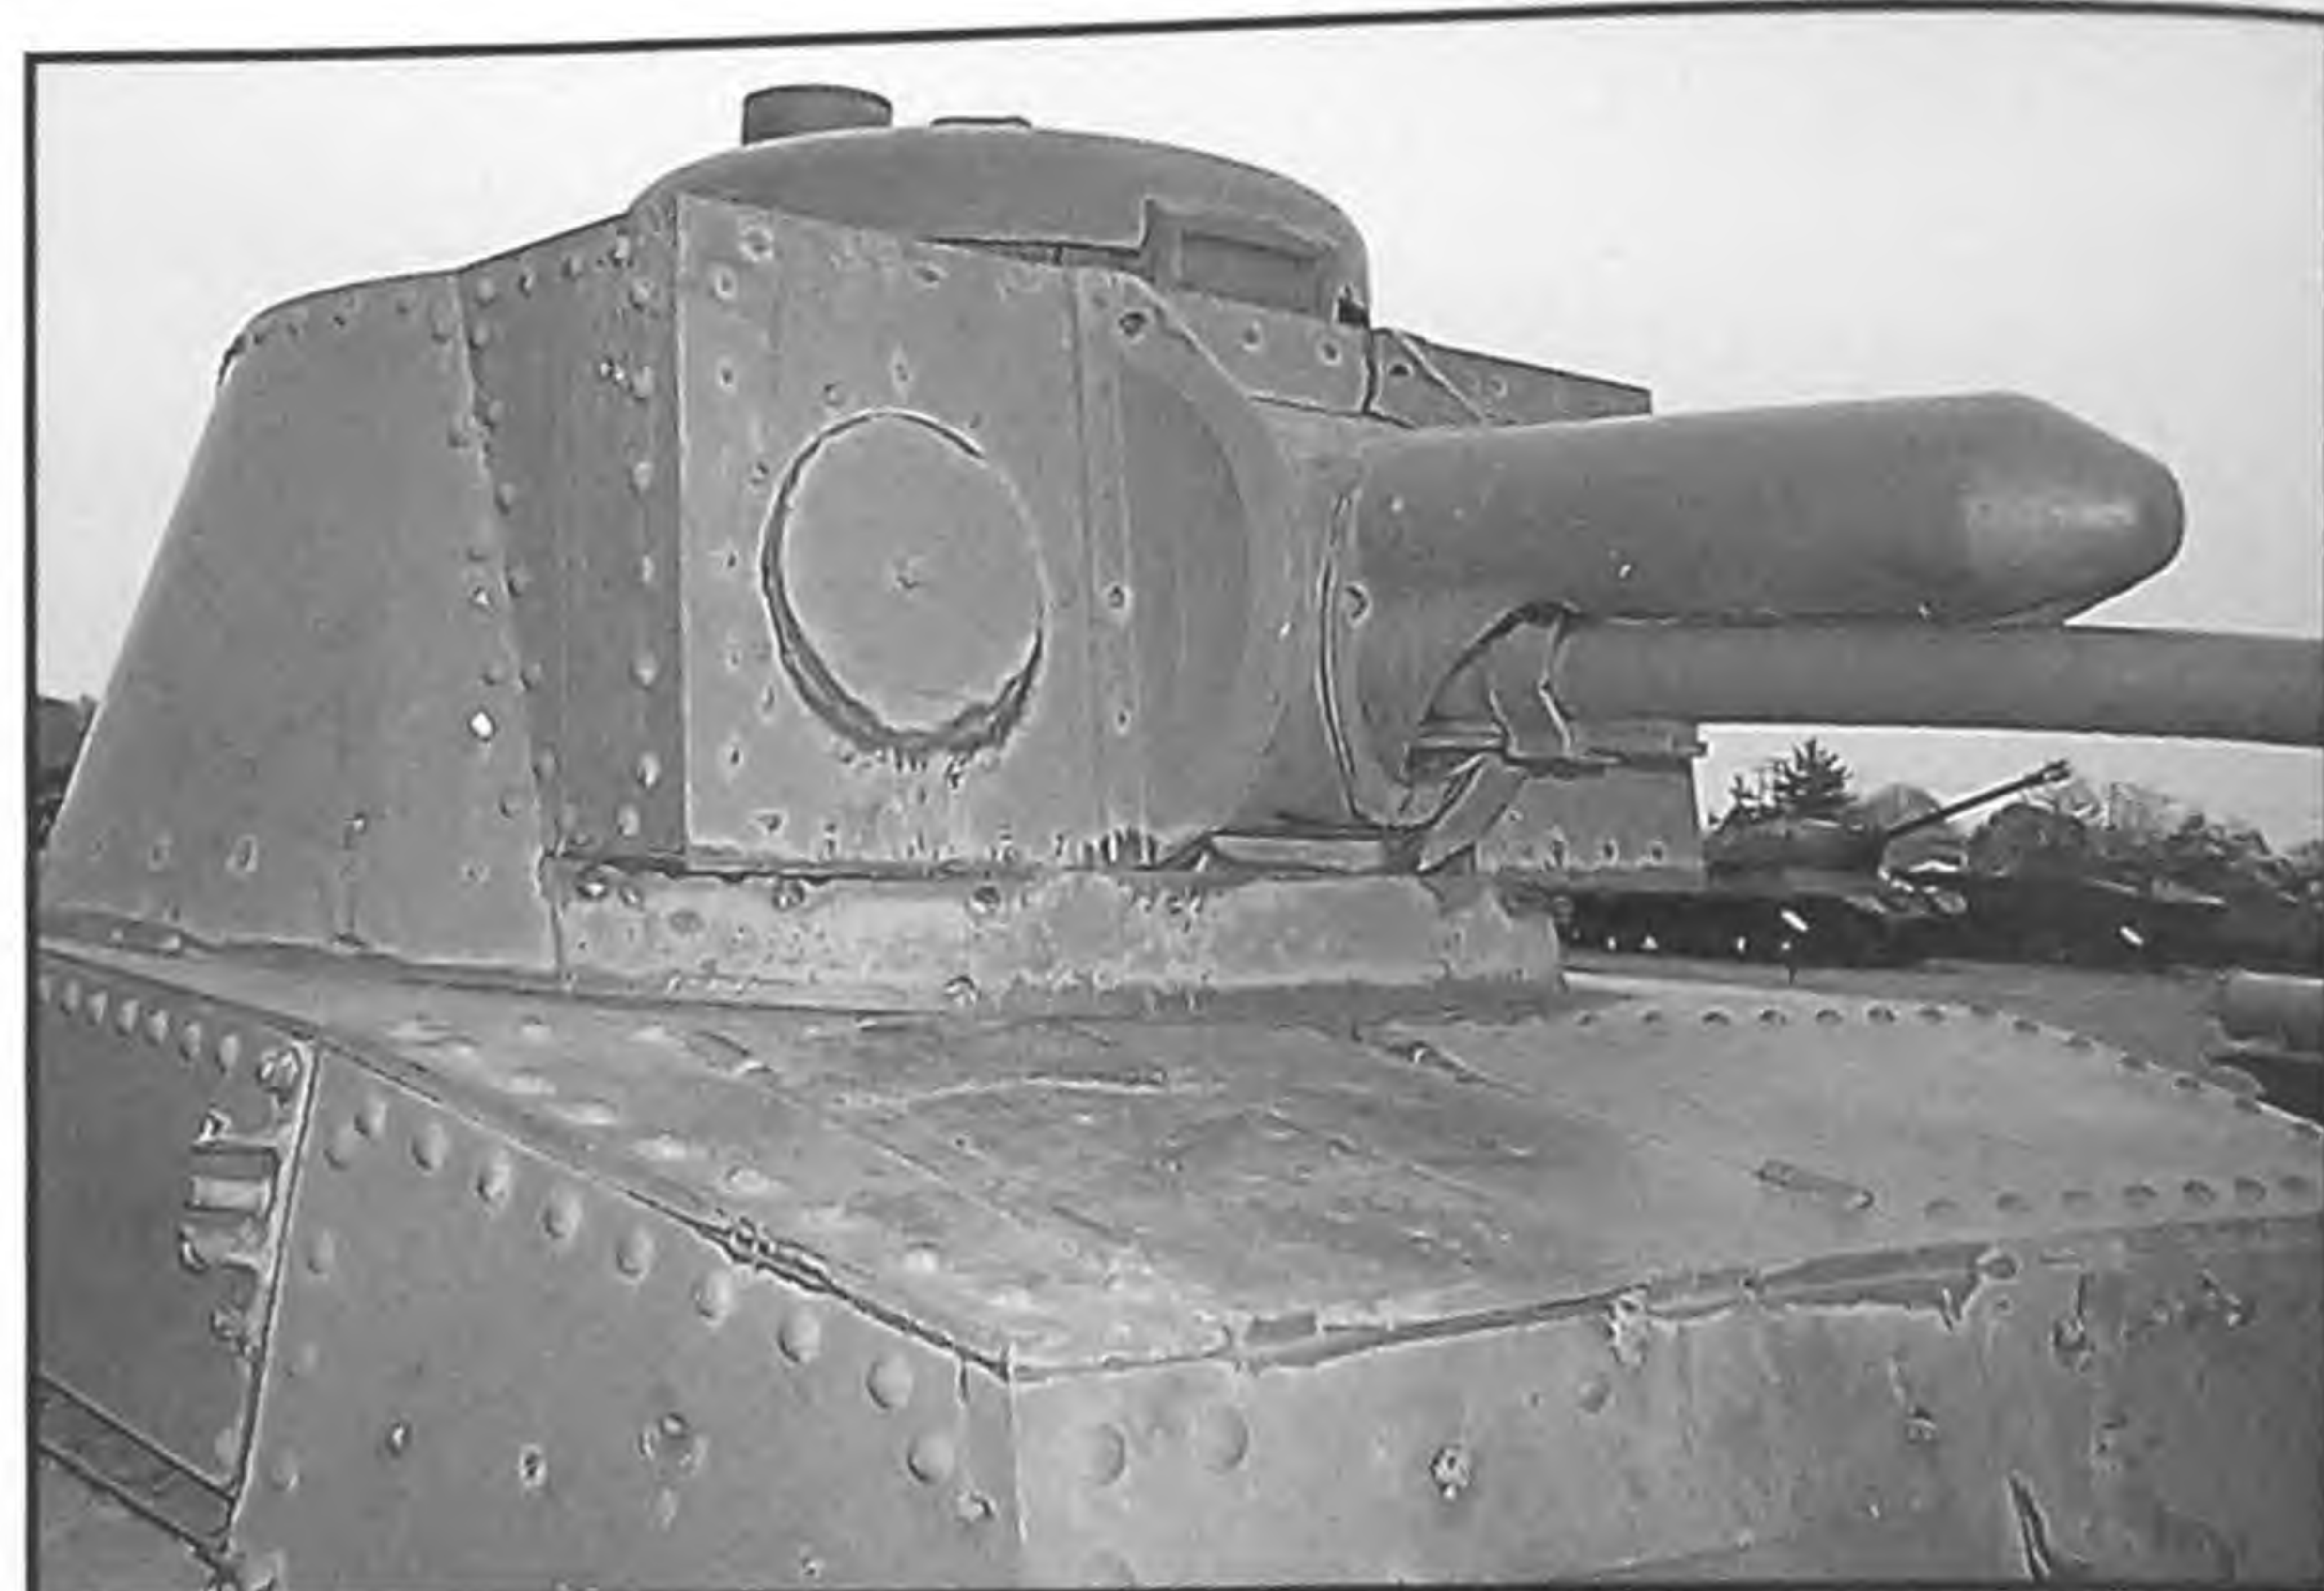
**Top left:** An overall view of the main 3.7cm gun. This weapon was highly effective for its day. It could penetrate up to 45mm of vertical armor at 500 meters and 25mm of 30° armor at 1,000 meters. The weapon utilized a semi-automatic breech mechanism and this allowed it to reach a substantial rate of

fire—up to 15 rounds per minute. **Top right:** The coaxially mounted 7.92-mm machine gun has been removed from the Aberdeen vehicle and a circular panel has been welded in its place. **Above left and right:** two views of the towed version of the 3.7cm gun on its wheeled carriage.

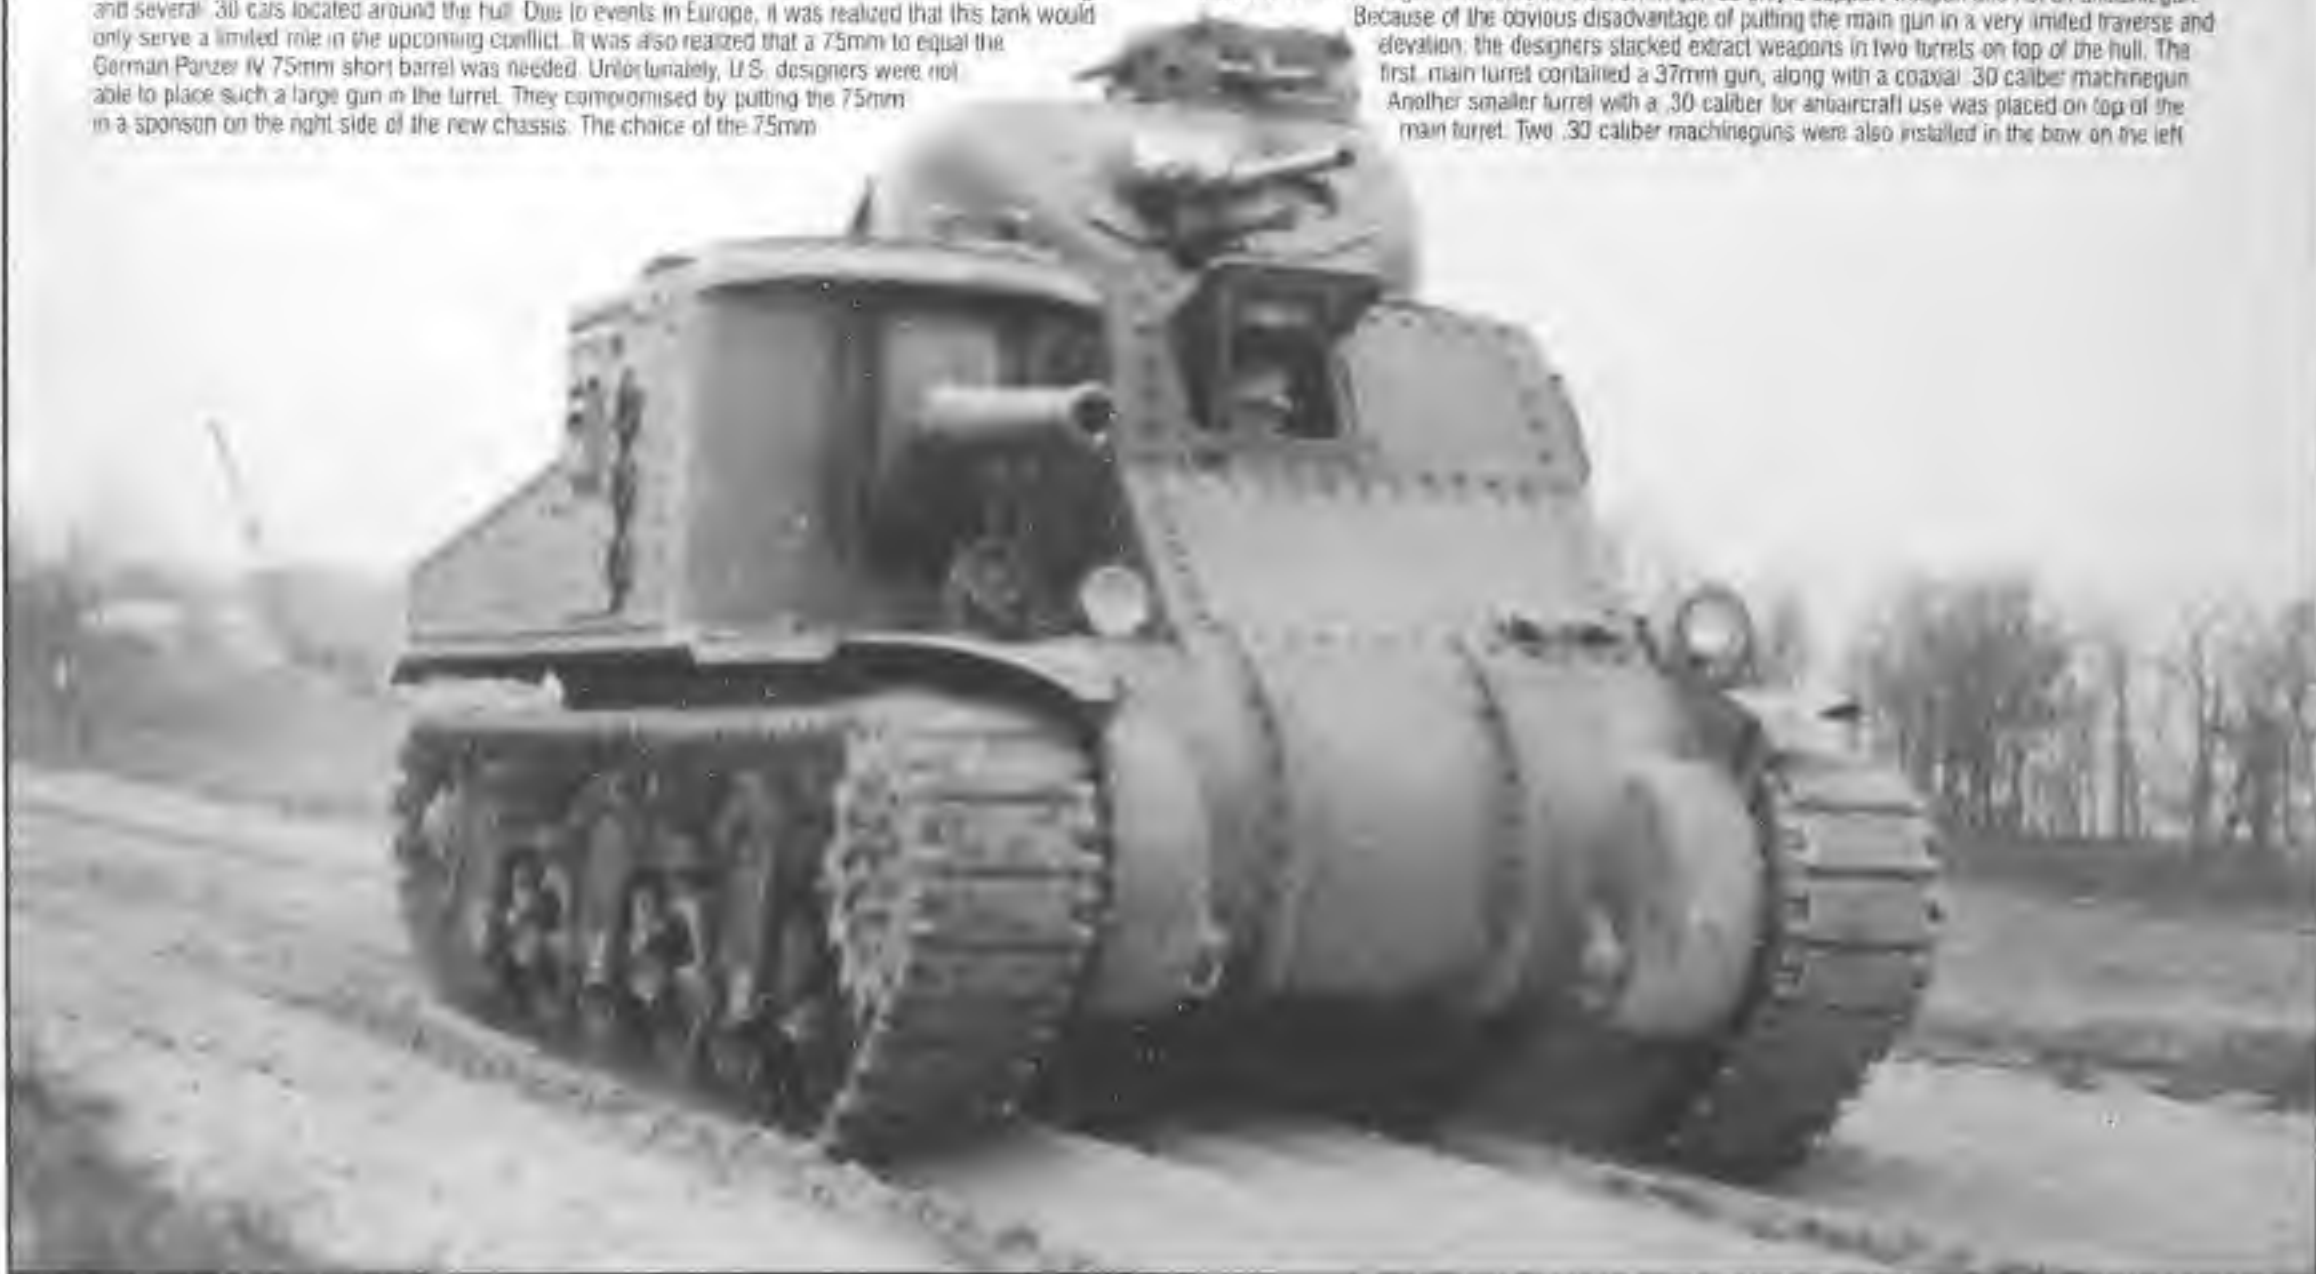
duced. The tank weighed 31 tons and used a 400 hp Wright R975 EC2 air-cooled radial engine. It could move the tank from 21 to 24 mph on roads and had a crew of seven. **Above:** An early M-3 Lee. The two bow .30 caliber machineguns are one of the best early identification features. Also the riveted hull and the large access doors on the hull sides. The short-barreled 75mm gun, the M2 previously

designated the T7, was a modified antiaircraft gun, the T6. The second barrel looking apparatus below the 37mm gun in the larger turret is actually a counterbalance weight. This may be a prototype of the Lee since it also does not have the large boxes, which are found on the rear deck of the later version of the Lee. All these M3's look like they are going through their paces at a test ground, possibly Aberdeen. (NARA)

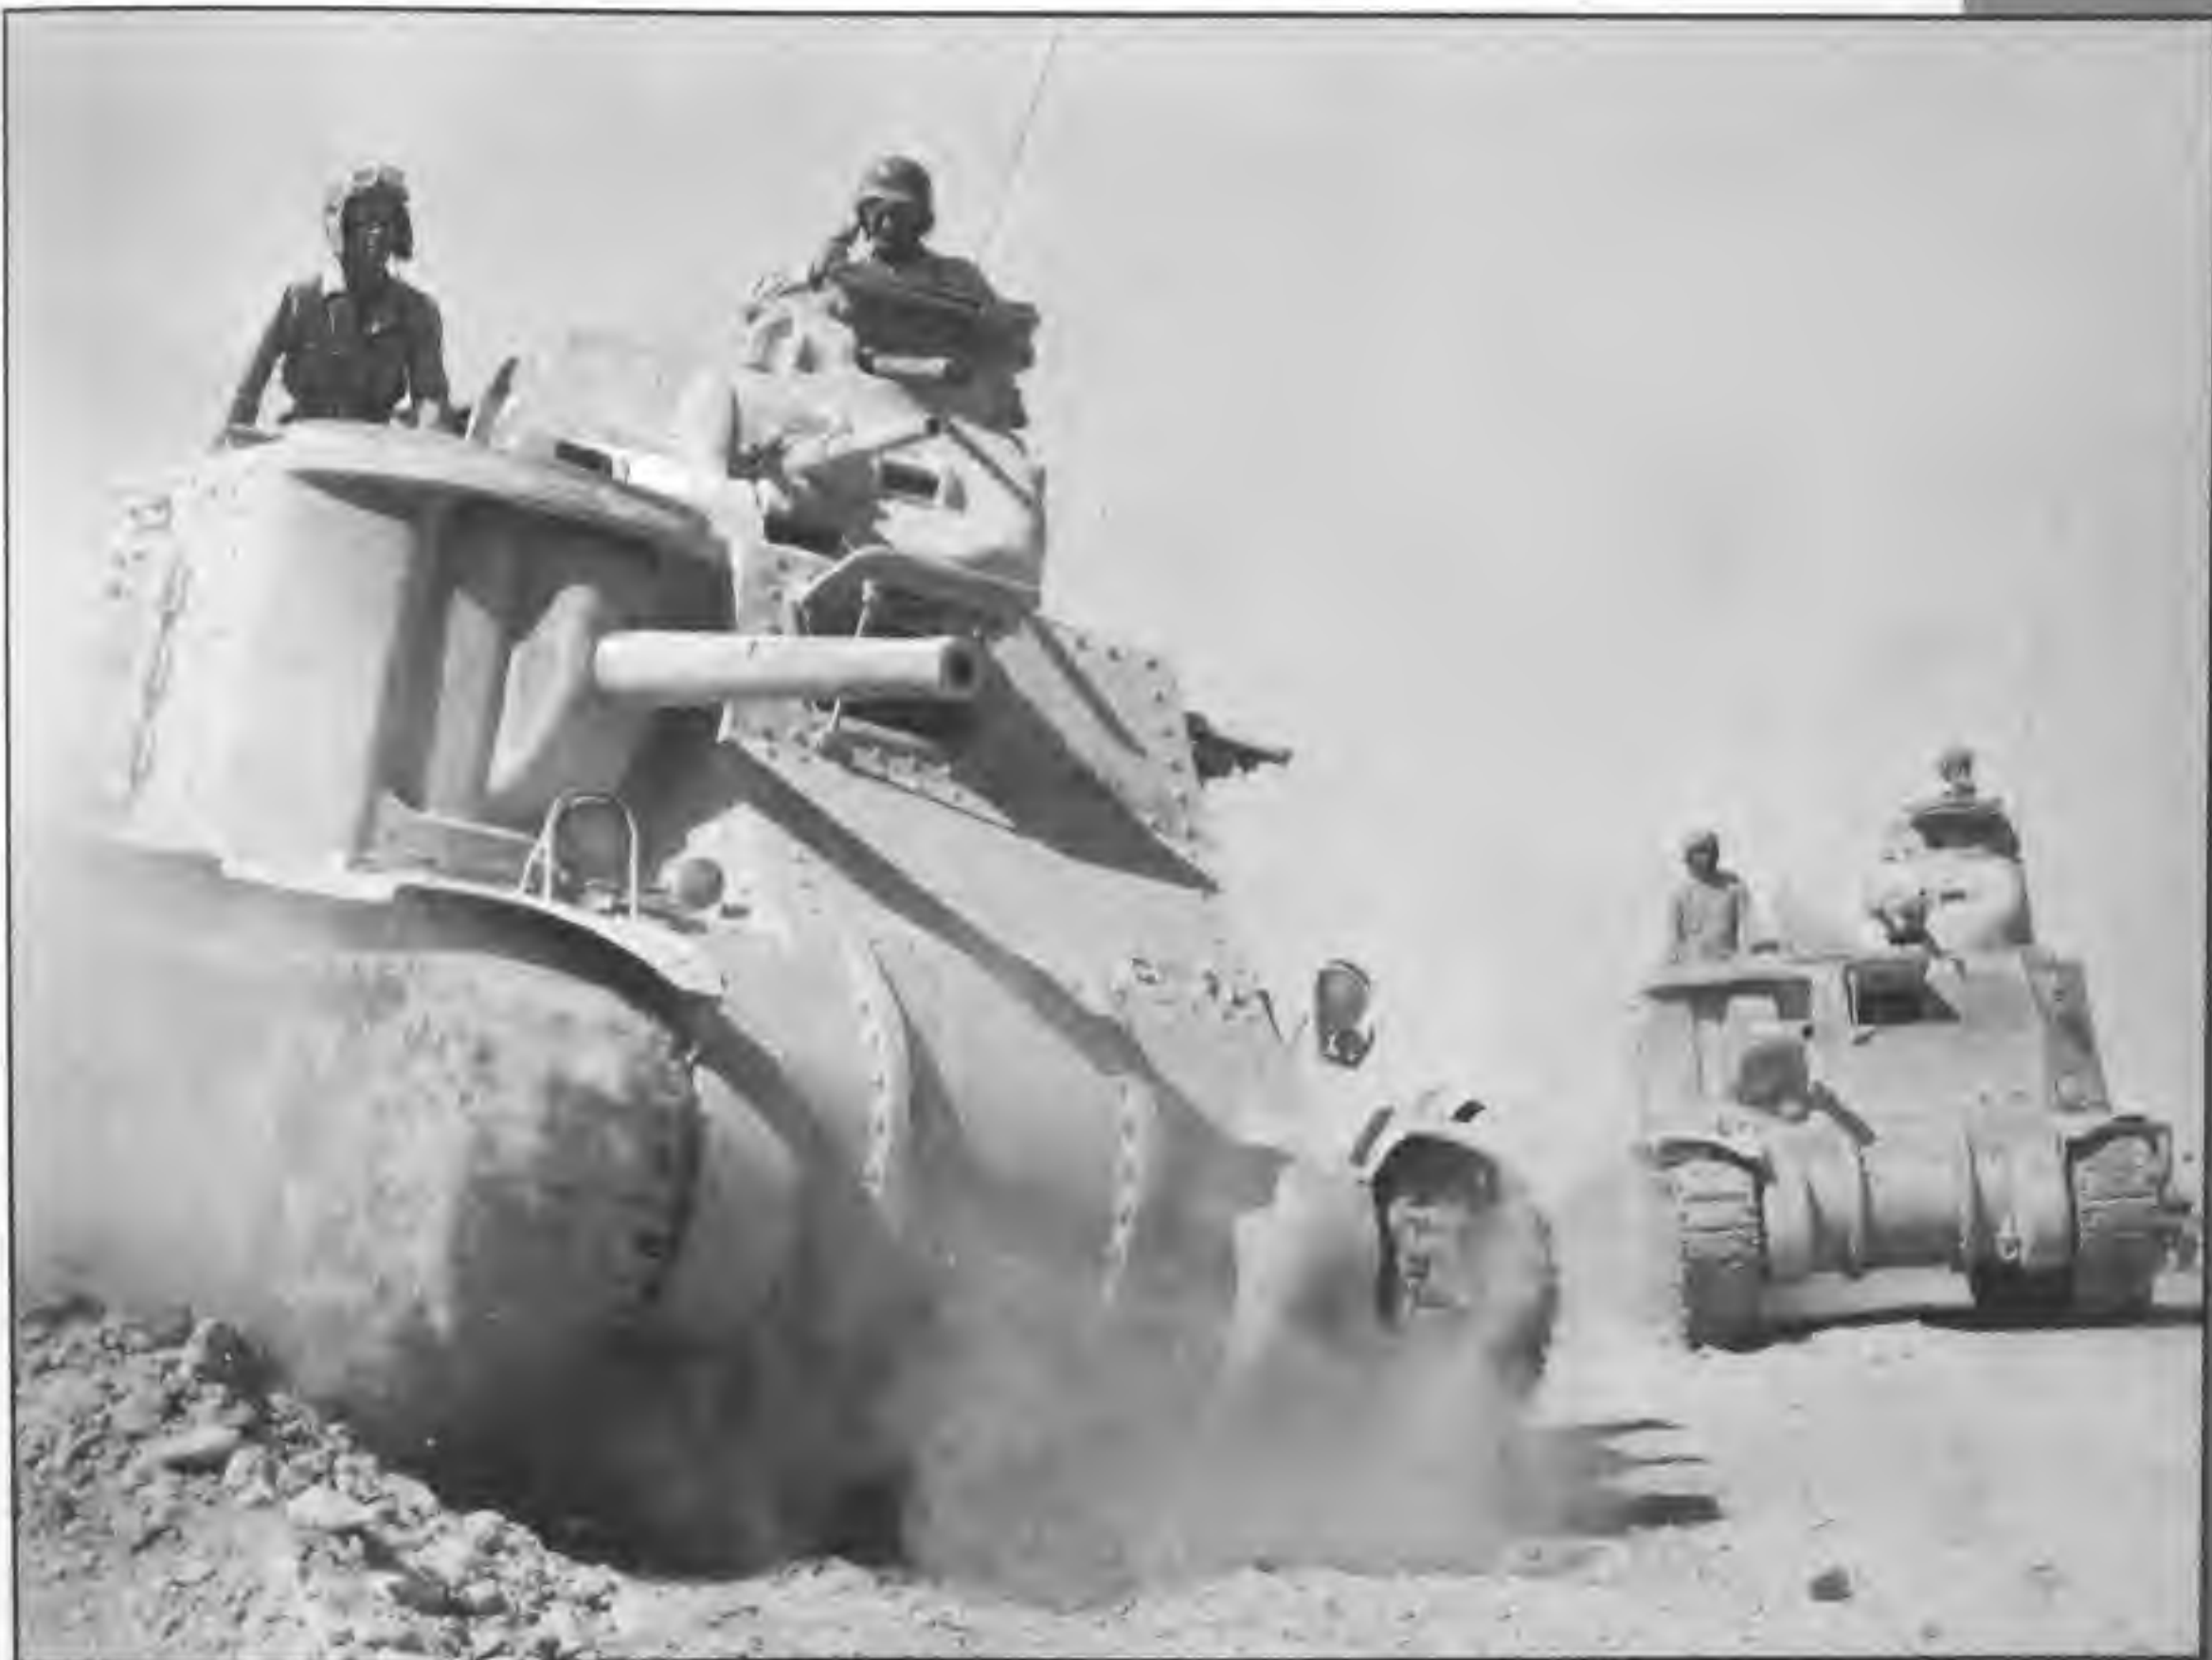
Chow time! Another shot from the Desert Warfare Center. This is a good view of the front three-piece differential housing. (NARA)

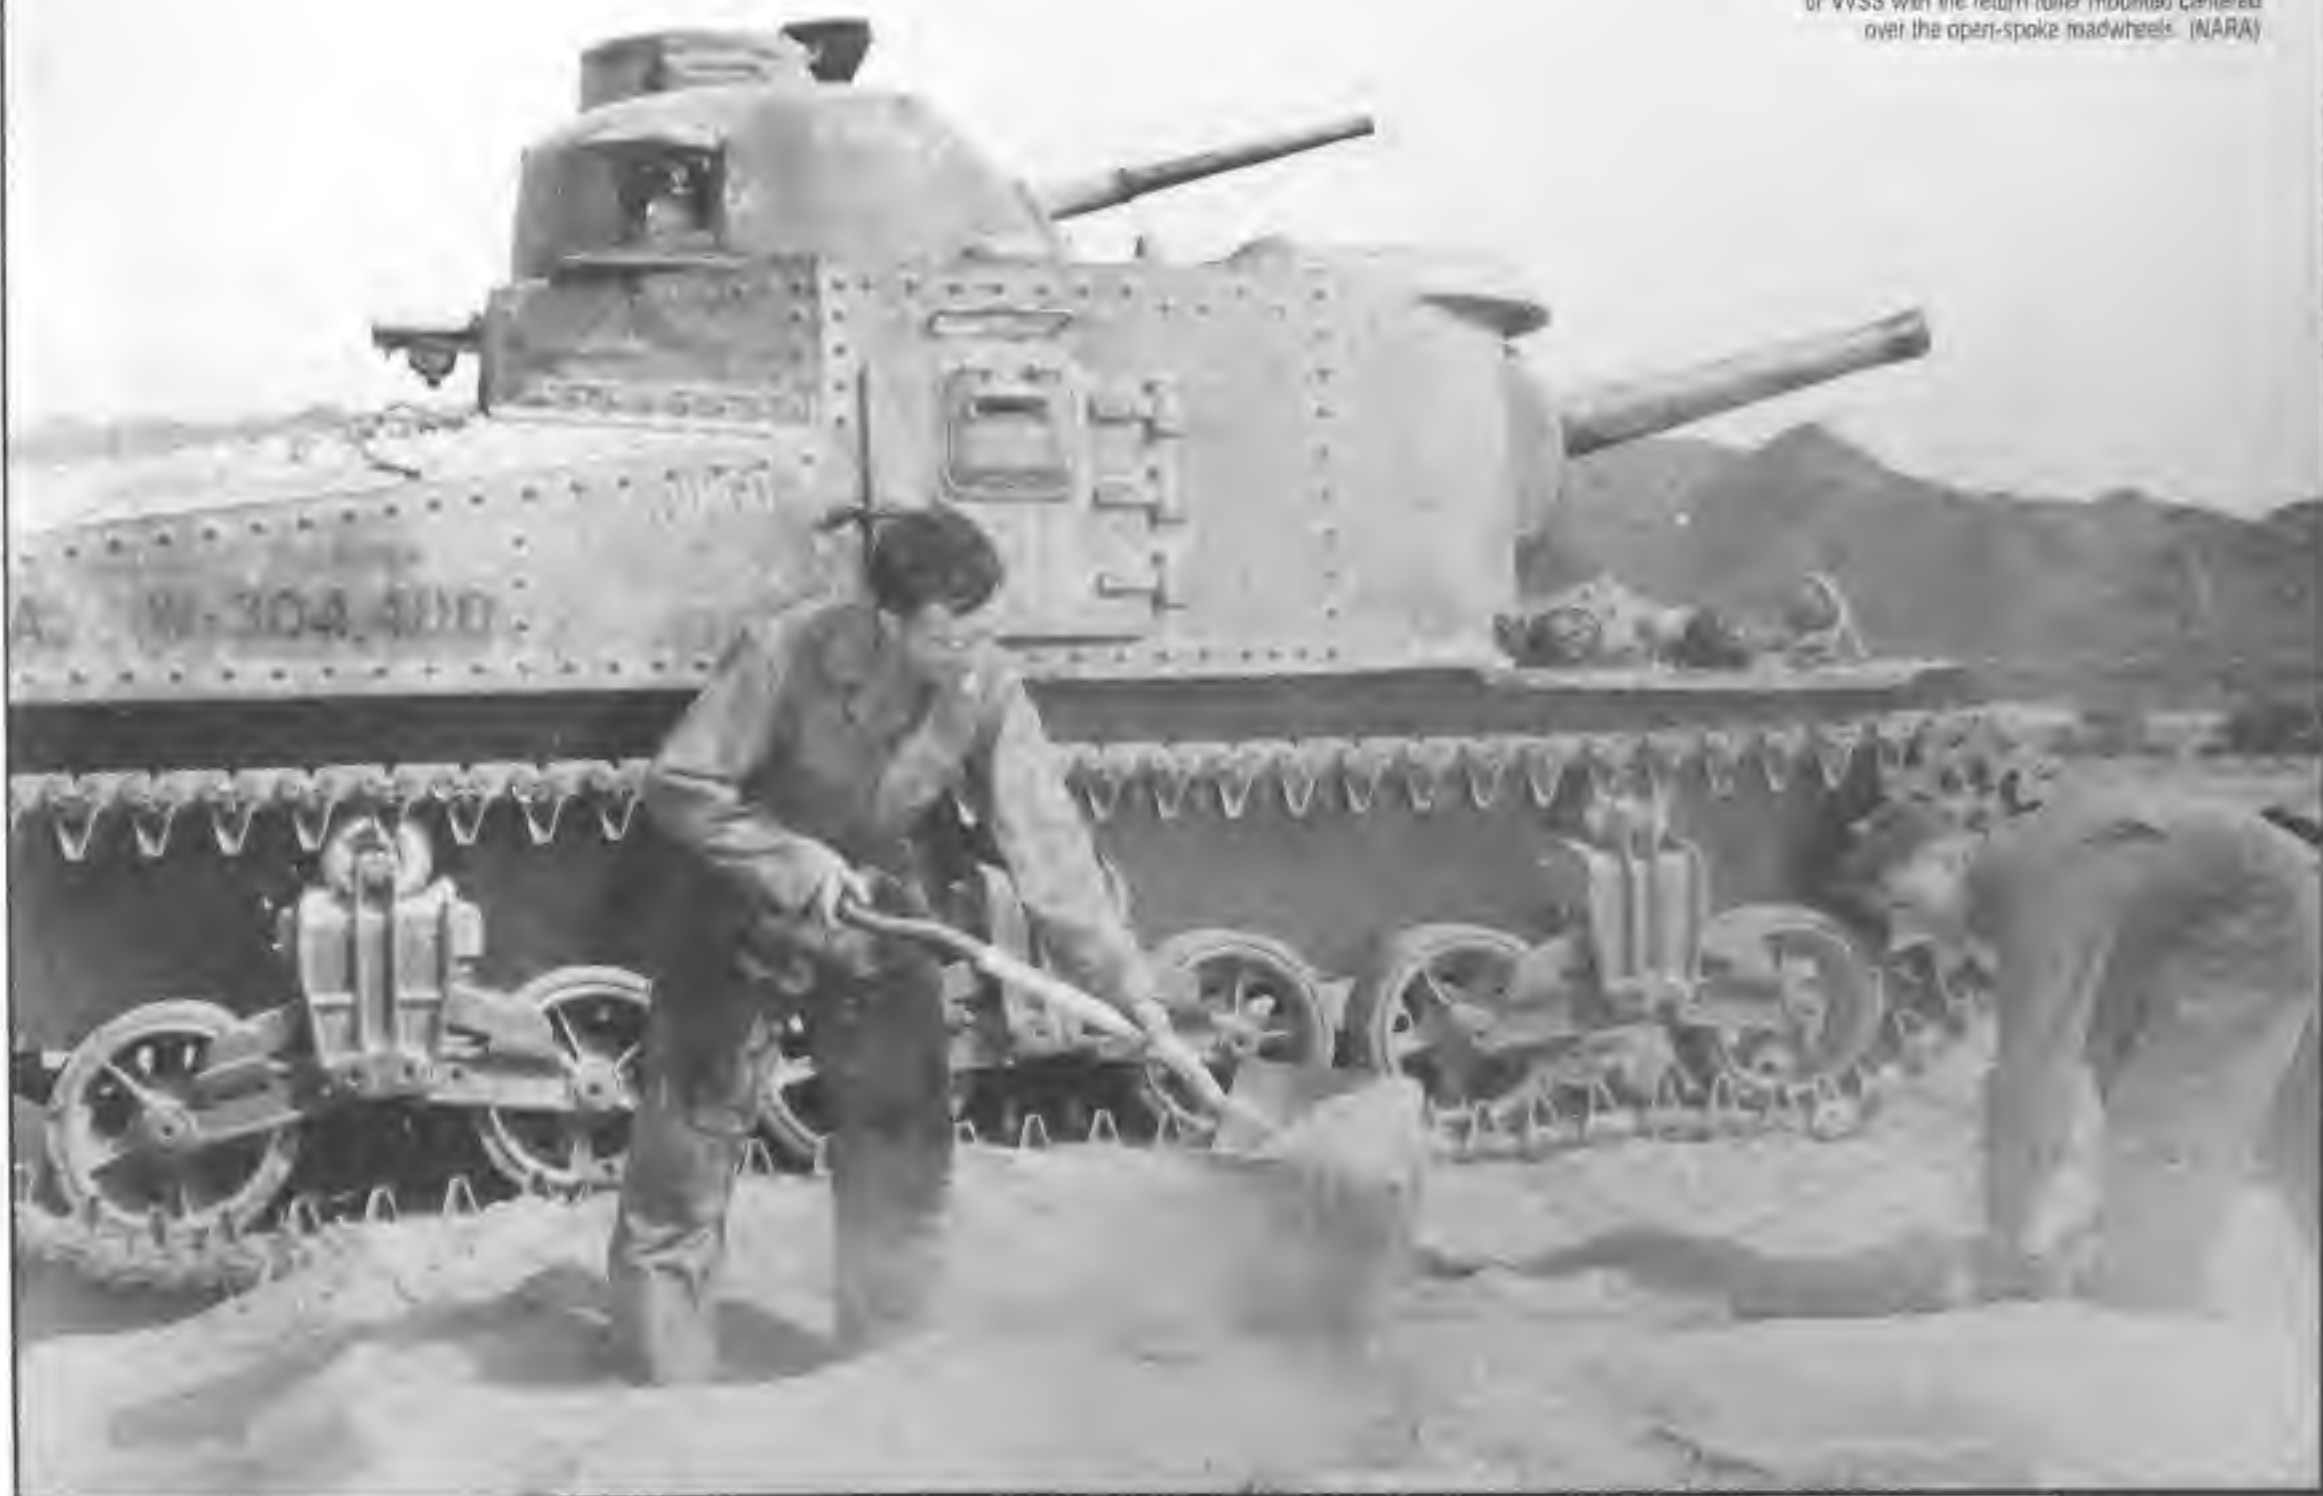
"Baseball" is a short barrel early production model M3. The counterweights around the 75mm gun to compensate for the shortened length of the gun can be seen. These counterweights were bolted on items, so they can either be present or not. The top is off the box on the front revealing the spare track links. (NARA)
